Bodie Island Light Station Double Keepers Quarters Historic Structure Report

Cape Hatteras National Seashore
Bodie Island Light Station
Double Keepers Quarters
Historic Structure Report

2009

Joseph K. Oppermann - Architect, P.A.

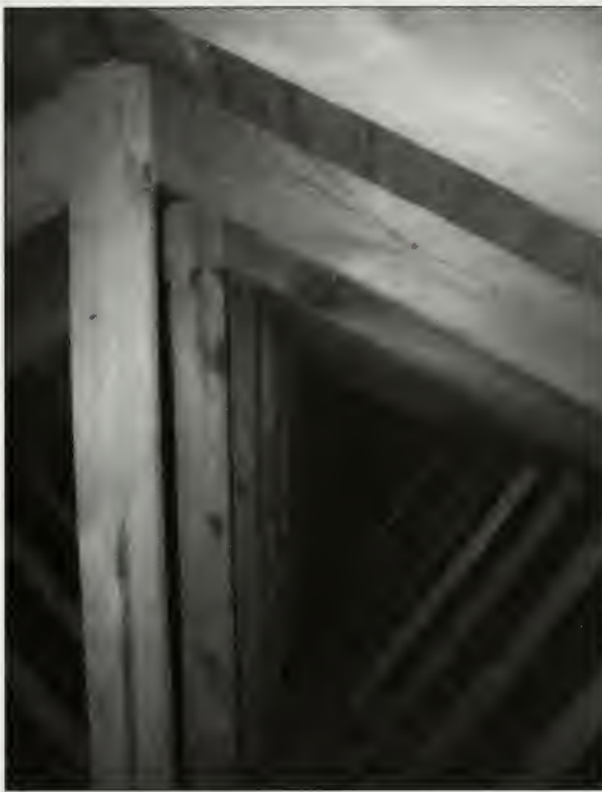
Also at some point, perhaps in 1954, a modern, 1⅝" by 5½" pine board was added as a vertical brace at the connection of each rafter pair and joist. Though not on the 1954 as-built plans these vertical boards were already installed by commencement of the 1990 repairs.

Figure 9, Vertical brace added at unknown date to apparently help support the 1954 oil heater.

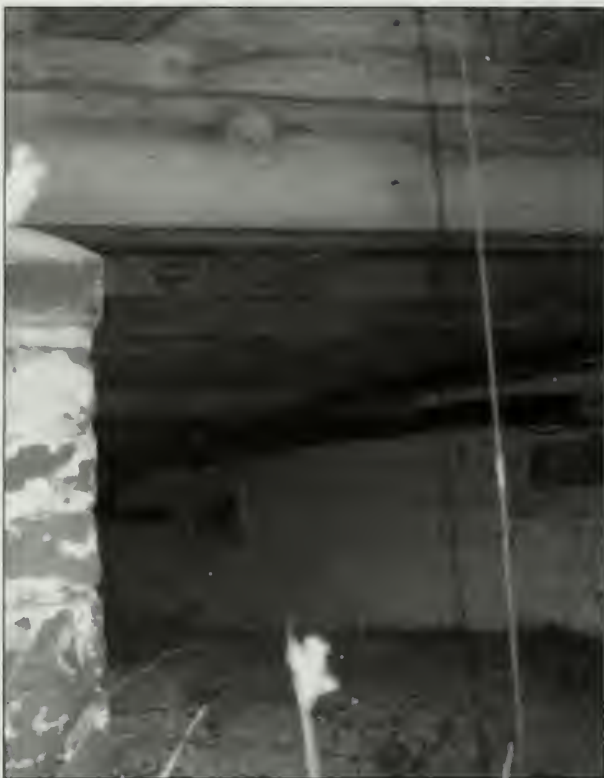
Figure 18, Replacement floor joists at West Porch.

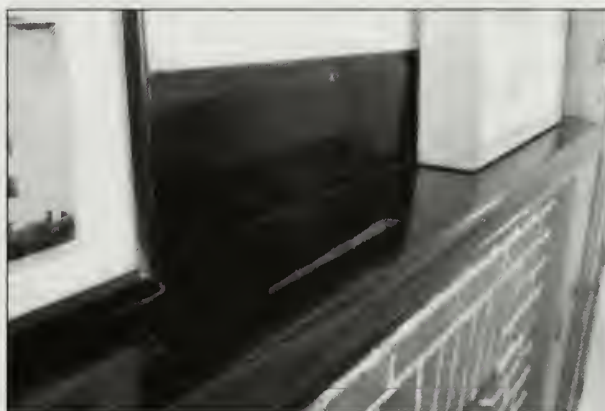
new brick hearth measuring 4'-3" wide and 2'-1" deep was laid. Also during those repairs, a Dutchman repair was made to the front of the mantel shelf. In 1954, the front of the shelf was hacked off to enclose the fireplace with a stud wall.

Figure 43, Dutchman repair (1990s) to mantel shelf, Room 101.

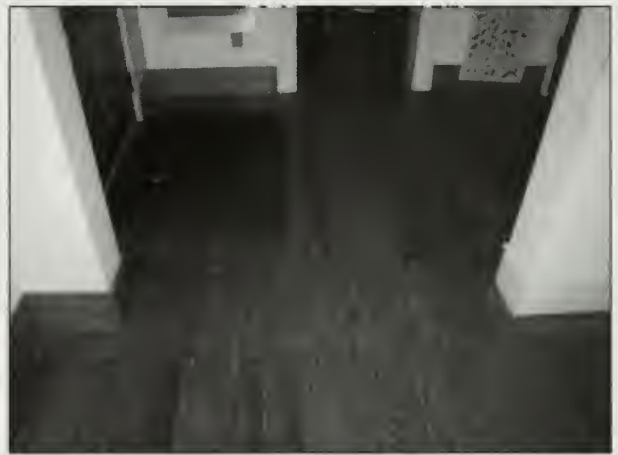
Figure 56, Floor patch at original dividing wall between Room 109 (foreground) and Room 108.
